INUNDATED AREA MAPS OF THE MALWATHU OYA BASIN FLOOD IN FEBRUARY 2011

HYDROLOGY AND DISASTER MANAGEMENT DIVISION **IRRIGATION DEPARTMENT SRI LANKA**

MARCH 2021

Inundation Maps of Malwathu Oya Flood in February 2011

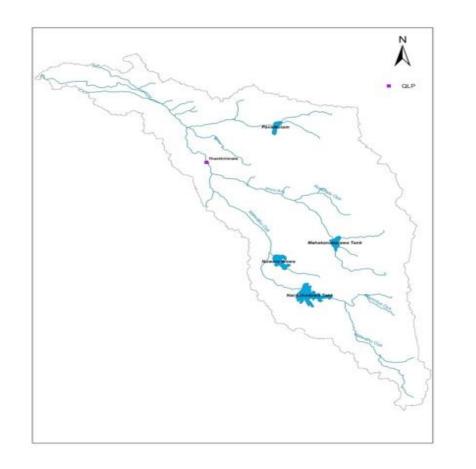
Figure I. The Malwathu Oya Basin with the Locations of Hydro-Meteorological Stations

River gauging history of the Malwathu Oya goes back to January 1943 when Kappachchi hydrometric station was established. Water levels had been recorded, 8.00 am to 5.00 pm (hourly) every week day at the beginning. However the station had been closed for 22 year period from 1983 to 2005 due to some reason. Twelve-hour recording (hourly) had been practiced from January 2013 to up to date. However, there are some periods of missing data during this period. Layout of these stations is shown in Figure 1. The recorded highest flood levels at two hydrometric stations are summarized in Table 1.

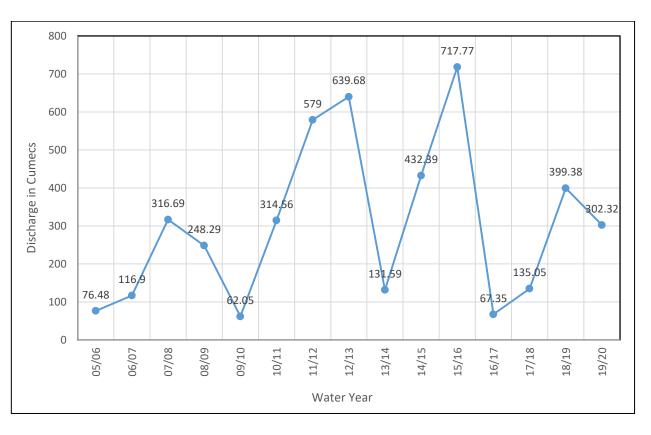
Figure 3. Annual Maximum Discharges at Tantirimale Gauging Station

This data series (Figure 3) is characterized with three flood peaks in January 2013, November 2015 and December 2019. These two events show somewhat similar nature but the latter is higher with respect to the duration of inundation and the damages experienced.

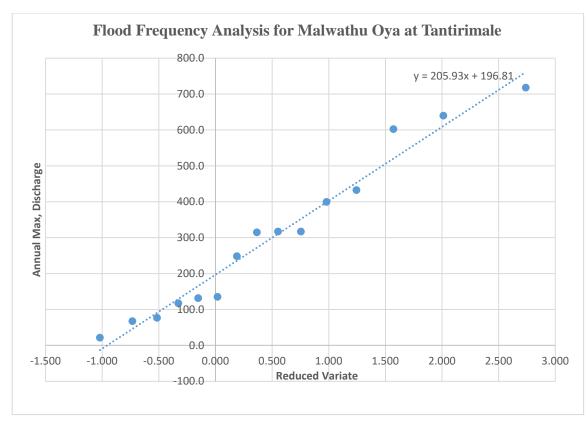
Figure 4. Gumbel Distribution with Annual Maximum Flood Discharges

Using the limited values of discharge data, flood frequency analysis was carried out using Gumbel Distribution. The data series is fairly fit to the mathematical function as shown in figure 4.

Table 5 shows the flood discharges with respect to selected return periods from 2 year to 100 year. However the discharge values computed for higher return periods are of less confidence since the data period is short. According to this computation, the extreme events in 2008 and 2016 can be considered as the flood of 10 year return periods.

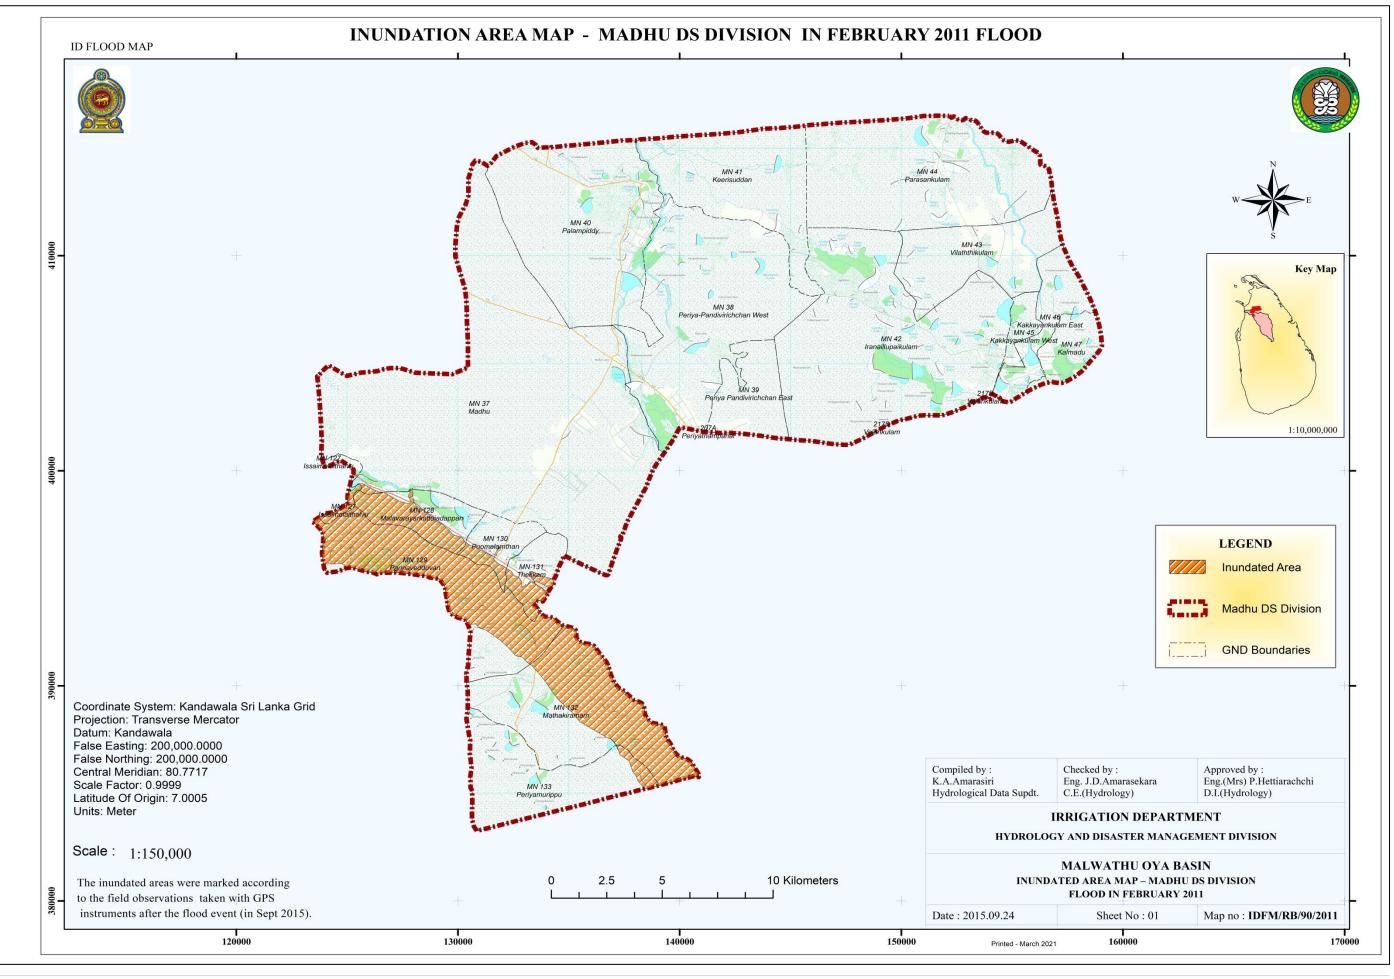
Nothern Province Mannar District								
MADHU	MN 132	Mathakiramam	34.39	18.73	54.45			
MADHU	MN 133	Periyamurippu	23.43	1.19	5.09			
MADHU	MN 129	Pannavedduvan	40.97	26.58	64.88			
MADHU	MN 128	Malavarayarkattaiadappan	10.07	5.75	57.13			
MADHU	MN 131	Thekkam	6.54	2.38	36.35			
MADHU	MN 130	Poomalarnthan	6.29	1.45	23.10			
MADHU	MN 37	Madhu	129.38	0.24	0.19			
Total			251.07	56.32	22.43

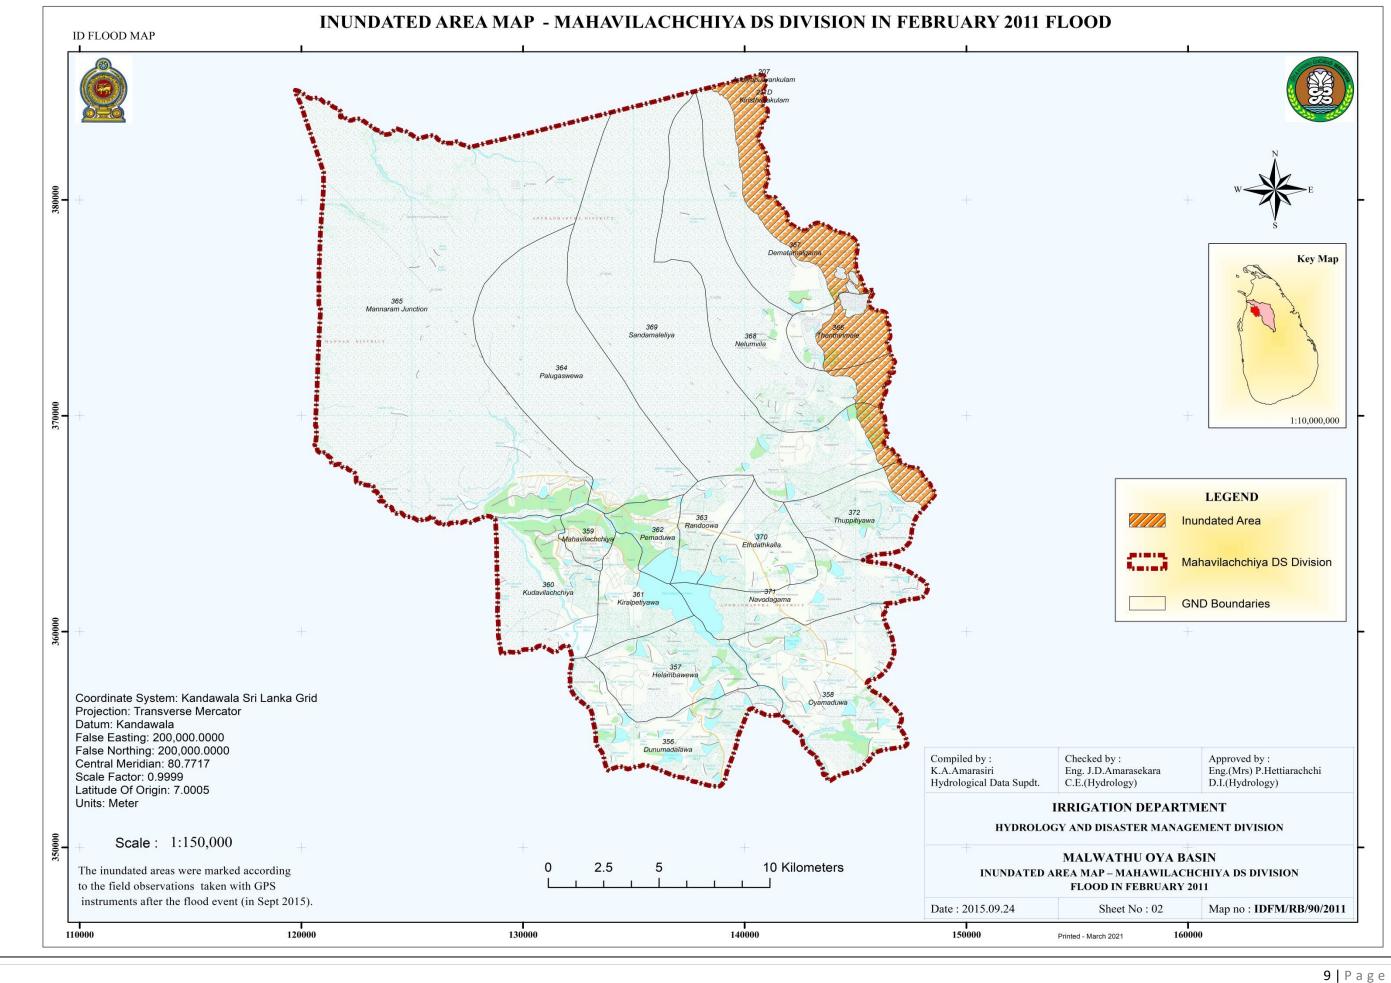
Inundated Areas in Mahavilachchiya Divisional Secretariat Division in December 2011 flood								
North Central Province								
Anuradhapura District	Anuradhapura District							
DS Division	GN Division NO	GN Division Name	Area Sq.Km.	Inundated Area Sq.Km.	Percentage %			
MAHAVILACHCHIYA	372	Thuppitiyawa	18.69	2.83	15.12			
MAHAVILACHCHIYA	366	Thanthirimale	12.46	7.47	59.96			
MAHAVILACHCHIYA	367	Dematamalgama	37.59	16.10	42.82			
MAHAVILACHCHIYA	368	Nelumvila	46.14	3.47	7.51			
MAHAVILACHCHIYA	369	Sandamaleliya	94.91	2.66	2.81			
Total			209.79	32.52	15.50

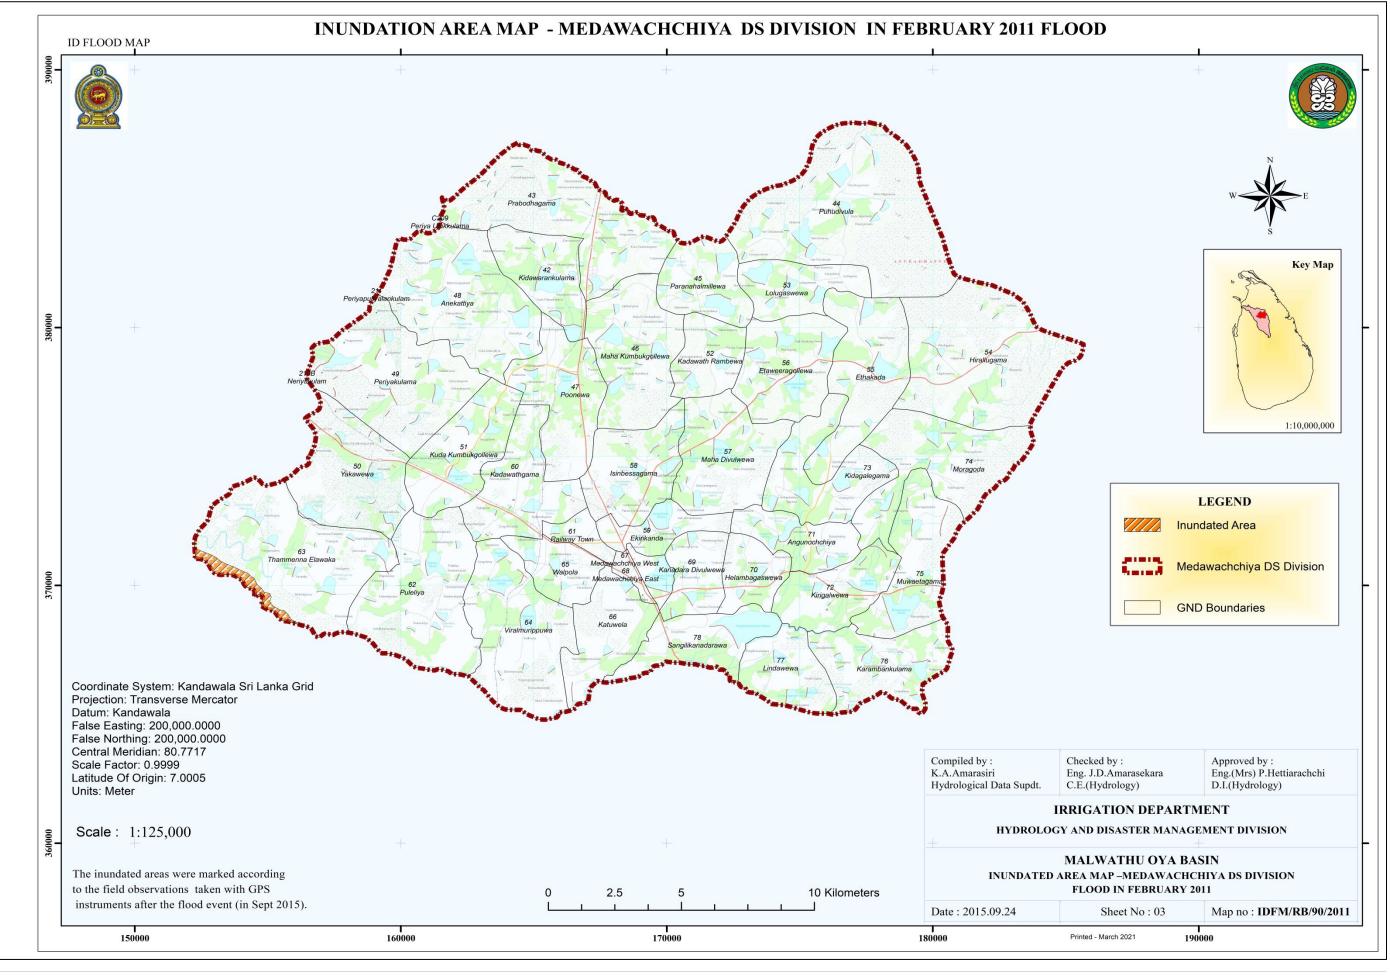
Inundated Areas in Medawachchiya Divisional Secretariat Division in December 2011 flood									
North Central Province	North Central Province								
Anuradhapura District	Anuradhapura District								
DS Division	GN Division NO	GN Division Name	Area Sq.Km.	Inundated Area Sq.Km.	Percentage %				
MEDAWACHCHIYA	63	Thammenna Elawaka	25.83	1.54	5.96				
Total			25.83	1.54	5.96

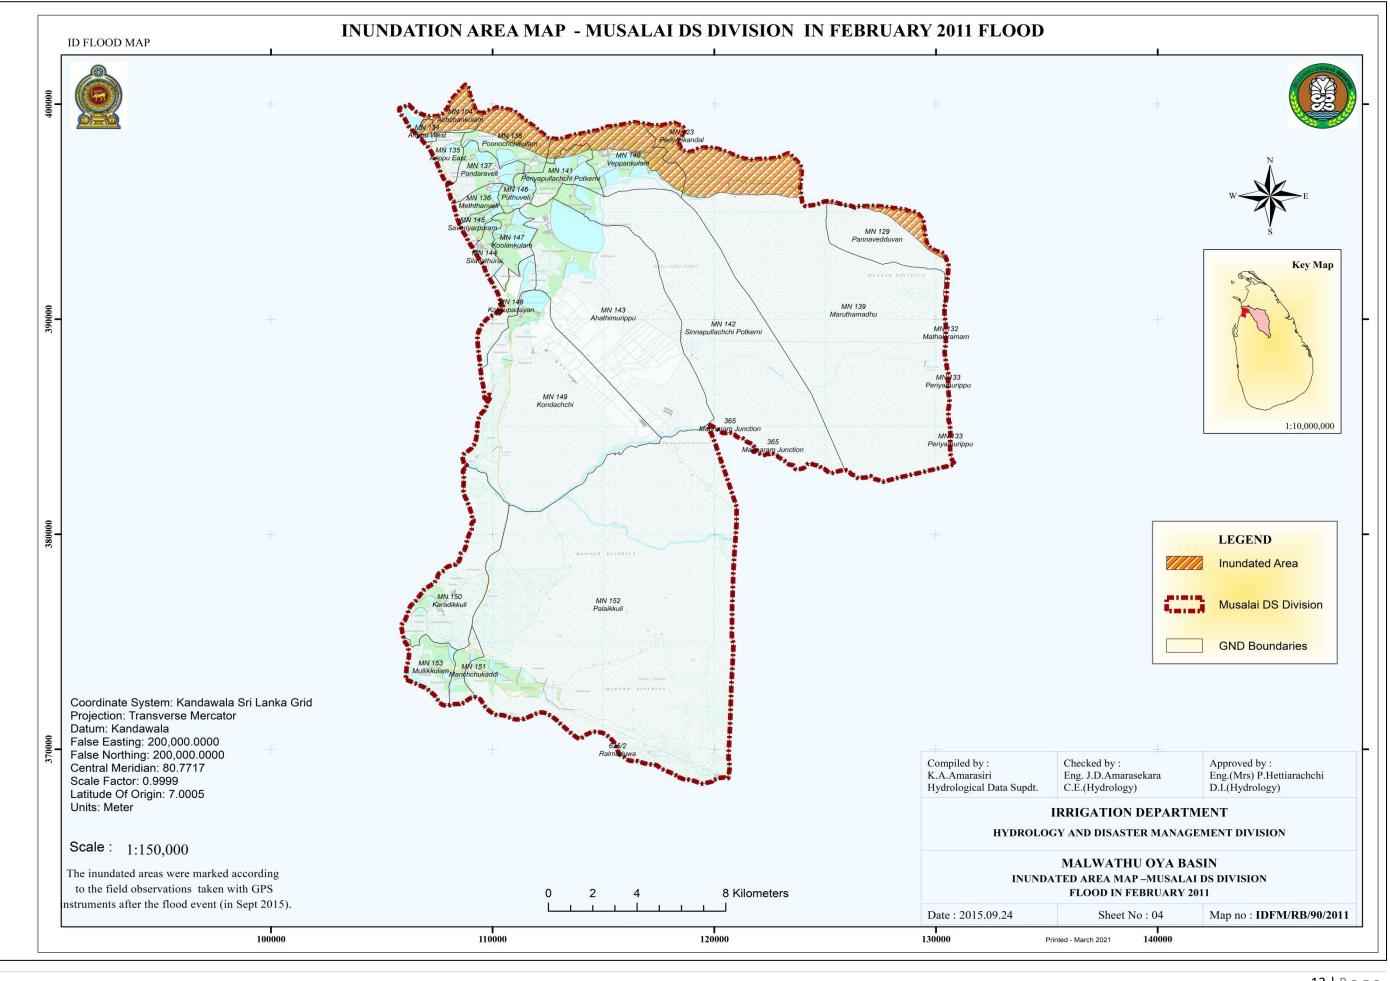
In	Inundated Areas in Musalai Divisional Secretariat Division in December 2011 flood							
Nothern Province	Nothern Province							
Mannar District								
DS Division	GN Division NO	GN Division Name	Area Sq.Km.	Inundated Area Sq.Km.	Percentage %			
MUSALAI	MN 139	Maruthamadhu	98.11	12.08	12.31			
MUSALAI	MN 138	Poonochchikulam	7.12	3.87	54.38			
MUSALAI	MN 134	Arippu West	0.70	0.39	56.34			
MUSALAI	MN 140	Veppankulam	11.58	6.31	54.47			
MUSALAI	MN 141	Periyapullachchi Potkerni	4.97	0.50	10.07			
Total			122.48	23.15	18.90

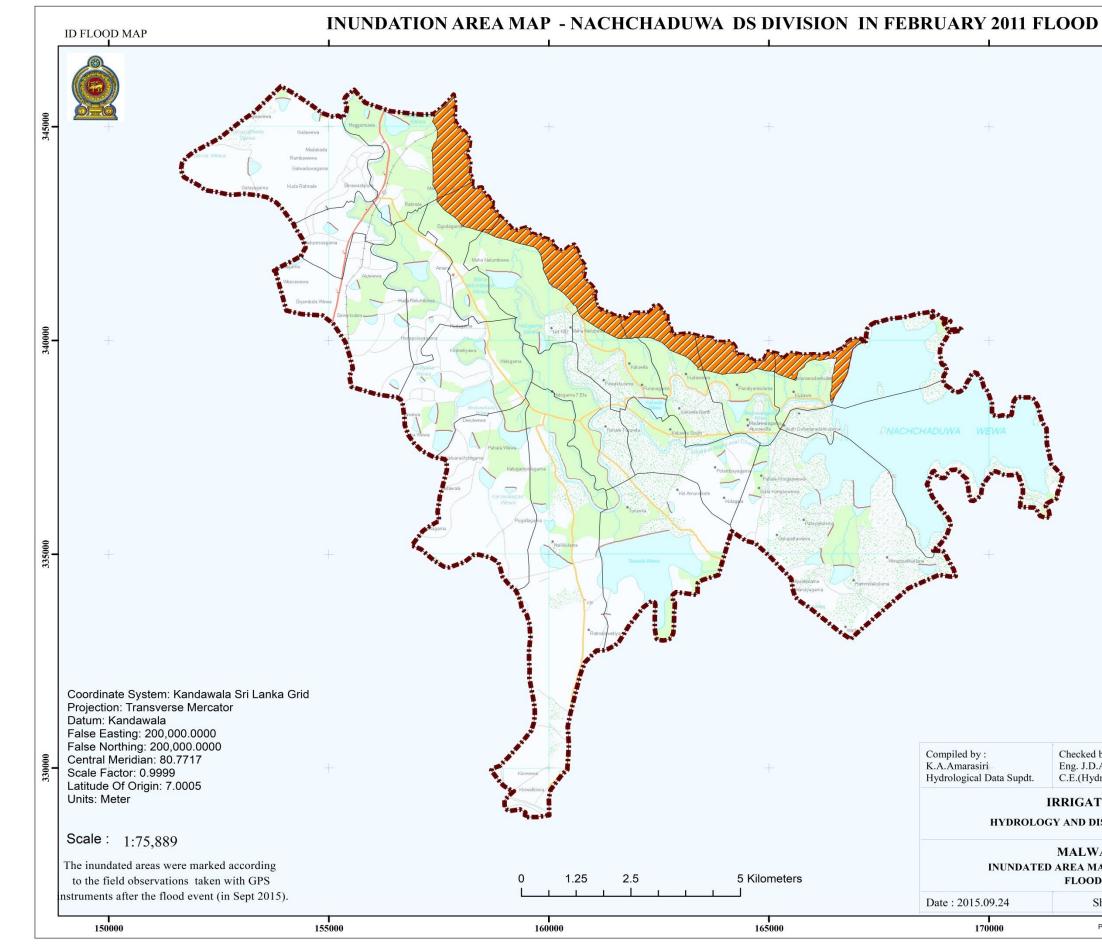
Sheet No : 05
 Map no : IDFM/RB/90/2011

MALWATHU OYA BASIN INUNDATED AREA MAP – NACHCHADUWA DS DIVISION FLOOD IN FEBRUARY 2011

Inundat	ted Areas in Nachch	aduwa Divisional Secreta	ariat Division in I	December 2011 flood	l		
North Central Province							
Anuradhapura District							
DS Division	GN Division NO	GN Division Name	Area Sq.Km.	Inundated Area Sq.Km.	Percentage %		
NACHCHADUWA	274	Kaluvila North	3.37	1.03	30.41		
NACHCHADUWA	265	Kudanelubewa	3.11	0.95	30.41		
NACHCHADUWA	259	Shrawasthipura	5.32	1.45	27.20		
NACHCHADUWA	266	Mahanelubewa	5.25	1.55	29.55		
NACHCHADUWA	267	Pawakkulama	3.28	0.48	14.56		
NACHCHADUWA	273	Madawalagama	3.01	0.94	31.17		
NACHCHADUWA	535	Nachchaduwa	5.95	0.79	13.31		
Total			29.30	7.18	24.51

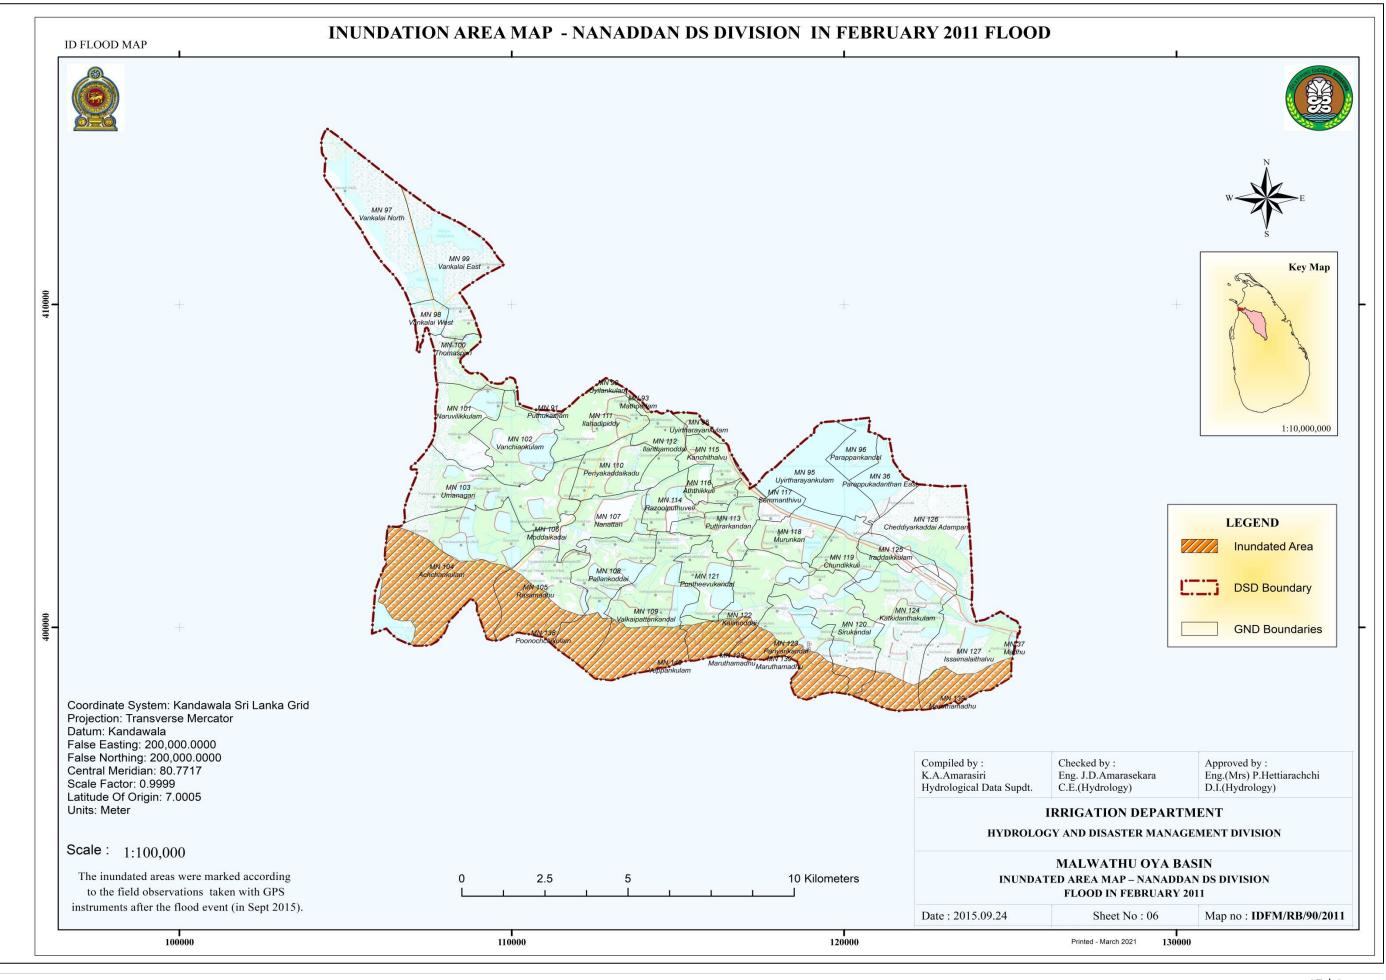
Inundated Areas in Nanaddan Divisional Secretariat Division in December 2011 flood							
Nothern Province							
Mannar District							
DS Division	GN Division NO	GN Division Name	Area Sq.Km.	Inundated Area Sq.Km.	Percentage %		
NANADDAN	MN 122	Kalimoddai	5.39	1.96	36.40		
NANADDAN	MN 123	Pariyarikandal	5.41	3.01	55.64		
NANADDAN	MN 120	Sirukandal	5.54	0.62	11.19		
NANADDAN	MN 104	Achchankulam	18.04	11.18	61.98		
NANADDAN	MN 124	Katkidanthakulam	8.46	1.56	18.40		
NANADDAN	MN 108	Pallankoddai	5.51	1.78	32.27		
NANADDAN	MN 121	Pontheevukandal	2.82	0.01	0.35		
NANADDAN	MN 109	Valkaipattankandal	8.67	3.85	44.38		
NANADDAN	MN 105	Rasamadhu	6.08	3.27	53.86		
NANADDAN	MN 127	Issaimalaithalvu	8.60	3.14	36.53		
Total			58.17	24.78	42.61

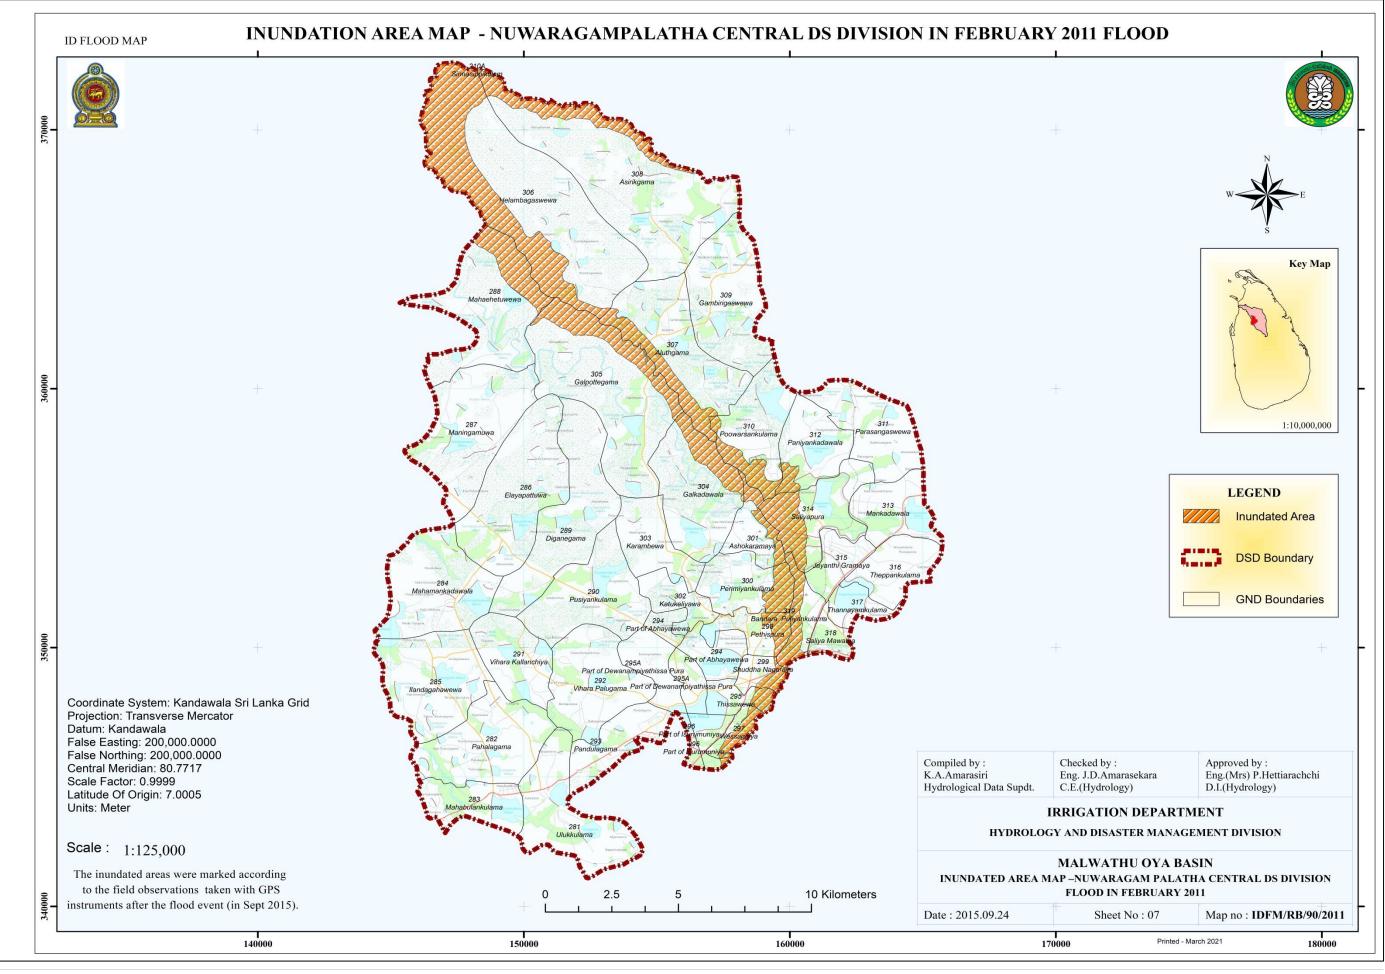
Inundated Areas in	Nuwaragam Palatha Cer	ntral Divisional Secretariat Di	ivision in Decembe	r 2011 flood		
North Central Province						
Anuradhapura District						
DS Division	GN Division NO	GN Division Name	Area Sq.Km.	Inundated Area Sq.Km.	Percentage %	
NUWARAGAM PALATHA CENTRAL	319	Bandara Puliyankulama	3.40	2.00	58.74	
NUWARAGAM PALATHA CENTRAL	310	Poowarsankulama	9.35	2.14	22.86	
NUWARAGAM PALATHA CENTRAL	312	Paniyankadawala	7.13	0.70	9.76	
NUWARAGAM PALATHA CENTRAL	307	Aluthgama	14.62	3.36	23.00	
NUWARAGAM PALATHA CENTRAL	305	Galpottegama	22.66	4.36	19.26	
NUWARAGAM PALATHA CENTRAL	304	Galkadawala	12.83	2.54	19.79	
NUWARAGAM PALATHA CENTRAL	308	Asirikgama	28.92	4.08	14.10	
NUWARAGAM PALATHA CENTRAL	318	Saliya Mawatha	2.02	0.03	1.73	
NUWARAGAM PALATHA CENTRAL	301	Ashokaramaya	4.03	1.26	31.36	
NUWARAGAM PALATHA CENTRAL	288	Mahaehetuwewa	15.95	3.38	21.19	
NUWARAGAM PALATHA CENTRAL	300	Perimiyankulama	6.83	1.63	23.84

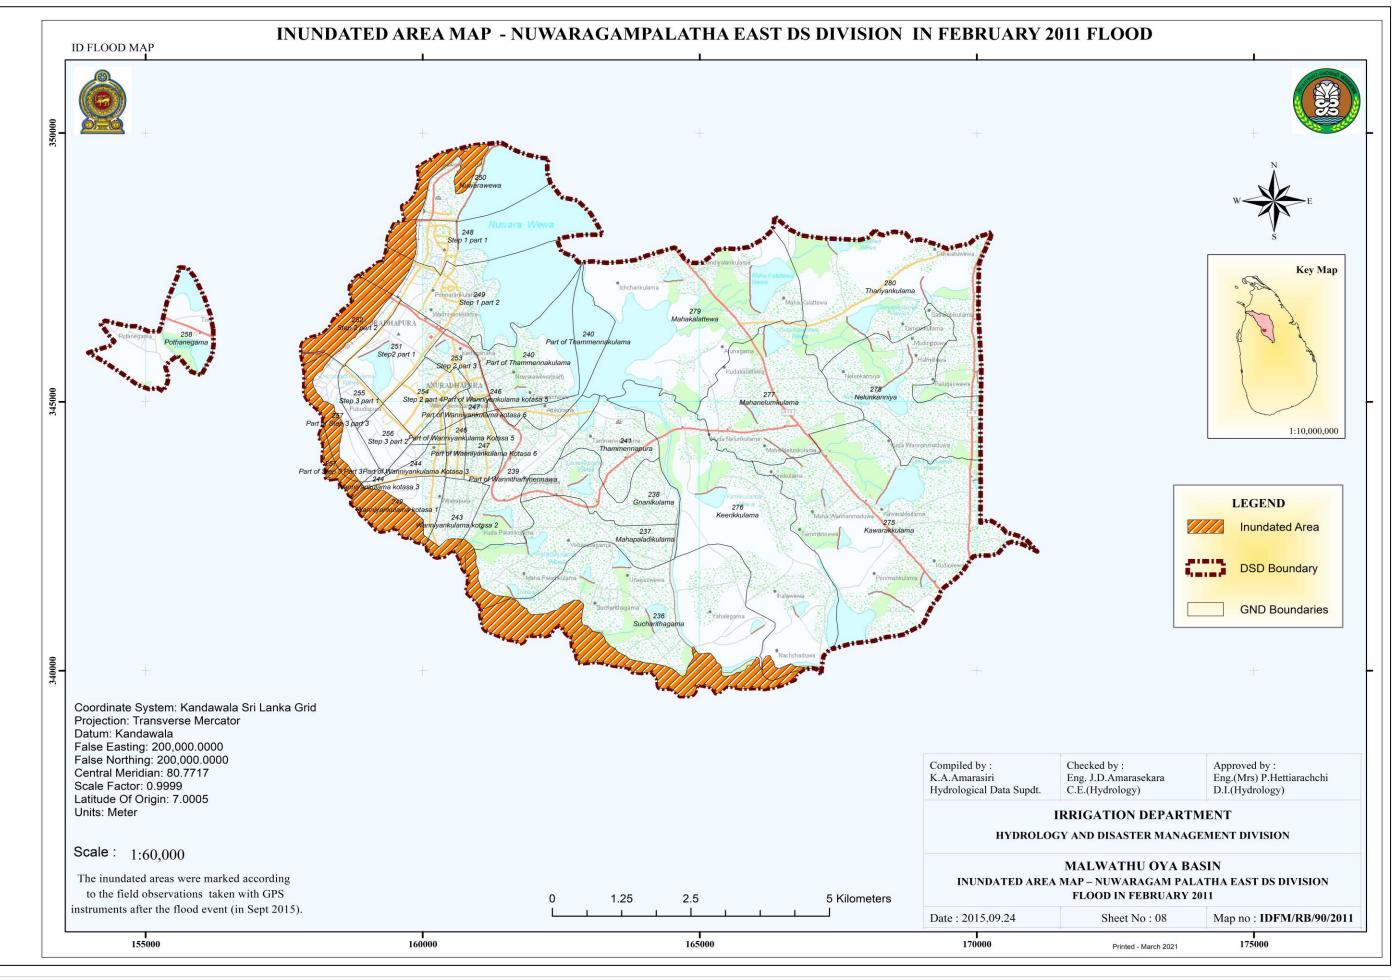
Inundated Areas in Nu	waragam Palath	na East Divisional Secretariat Division	in December 2	2011 flood			
North Central Province							
Anuradhapura District							
DS Division	GN Division NO	GN Division Name	Area Sq.Km.	Inundated Area Sq.Km.	Percentage %		
NUWARAGAM PALATHA EAST	237	Mahapaladikulama	3.69	0.30	8.00		
NUWARAGAM PALATHA EAST	239	Part of Wannithammennawa	2.64	0.09	3.35		
NUWARAGAM PALATHA EAST	257	Part of Step 3 part 3	1.39	0.57	40.73		
NUWARAGAM PALATHA EAST	244	Part of Wanniyankulama Kotasa 3	0.46	0.02	4.26		
NUWARAGAM PALATHA EAST	252	Step 2 part 2	1.34	0.95	70.99		
NUWARAGAM PALATHA EAST	276	Keerikkulama	7.92	0.16	2.02		
NUWARAGAM PALATHA EAST	243	Wanniyankulama kotasa 2	0.93	0.13	14.46		
NUWARAGAM PALATHA EAST	242	Wanniyankulama kotasa 1	1.43	0.74	52.05		
NUWARAGAM PALATHA EAST	236	Sucharithagama	9.22	2.47	26.84		
NUWARAGAM PALATHA EAST	250	Nuwarawewa	2.72	0.68	25.12		
NUWARAGAM PALATHA EAST	248	Step 1 part 1	3.01	0.29	9.67

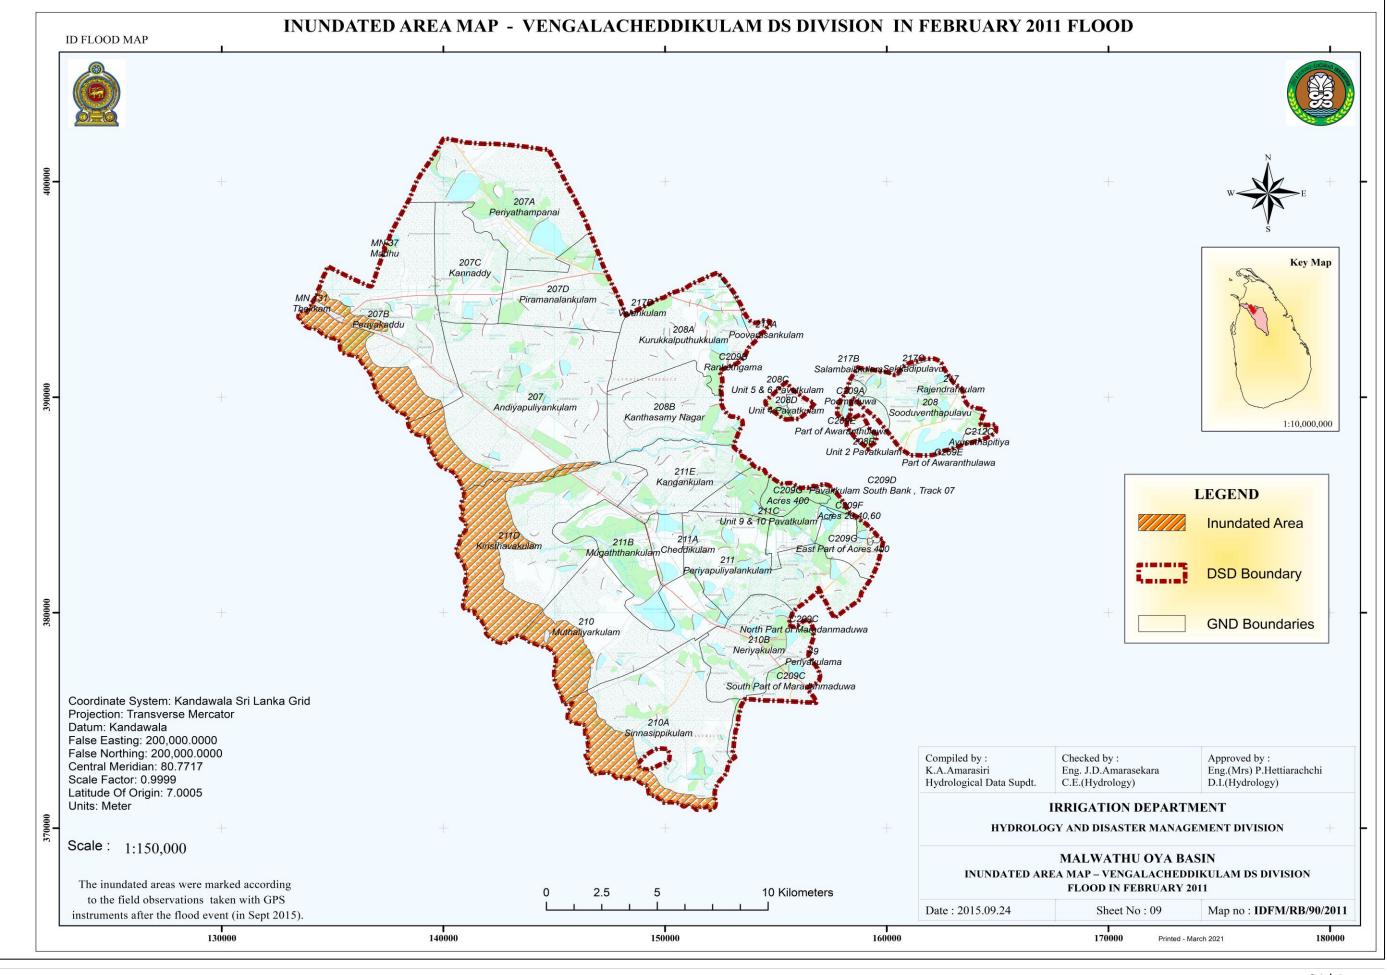
Inundated Areas in Vengalacheddikulam Divisional Secretariat Division in December 2011 flood							
Nothern Province							
Vavuniya District	Vavuniya District						
DS Division	GN Division NO	GN Division Name	Area Sq.Km.	Inundated Area Sq.Km.	Percentage %		
VENGALACHEDDIKULAM	207B	Periyakaddu	36.54	9.88	27.04		
VENGALACHEDDIKULAM	207	Andiyapuliyankulam	53.09	6.32	11.90		
VENGALACHEDDIKULAM	211D	Kiristhavakulam	37.77	16.52	43.75		
VENGALACHEDDIKULAM	210	Muthaliyarkulam	29.11	6.37	21.89		
VENGALACHEDDIKULAM	210A	Sinnasippikulam	36.99	8.64	23.35		
Total			193.50	47.73	24.67
